# **INDOOR AIR QUALITY ASSESSMENT**

**Brockton Public Library East Branch  
54 Kingman Street  
Brockton, Massachusetts**

Prepared by:  
Massachusetts Department of Public Health  
Center for Environmental Health  
Bureau of Environmental Health Assessment  
March 2005

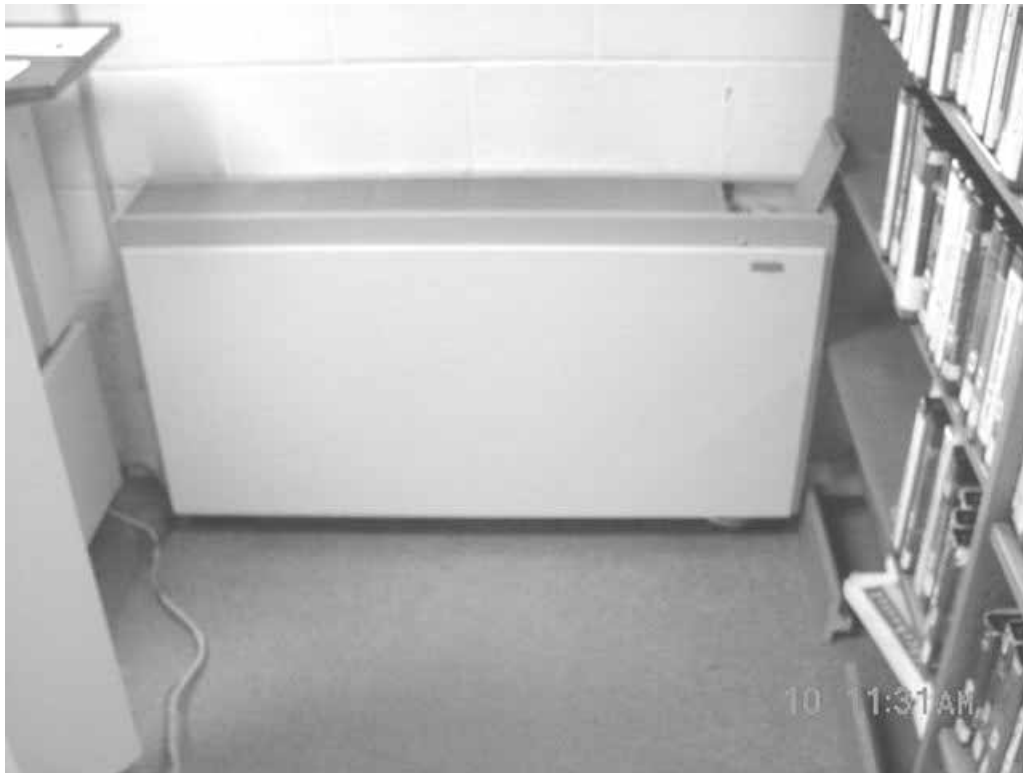
**Picture 1**

Fresh air is mechanically provided to the building through unit ventilator (univent) systems (Pictures 1 and 2). A univent draws air from outdoors through a fresh air intake

**Small Unit Ventilator on Main Level of Library**

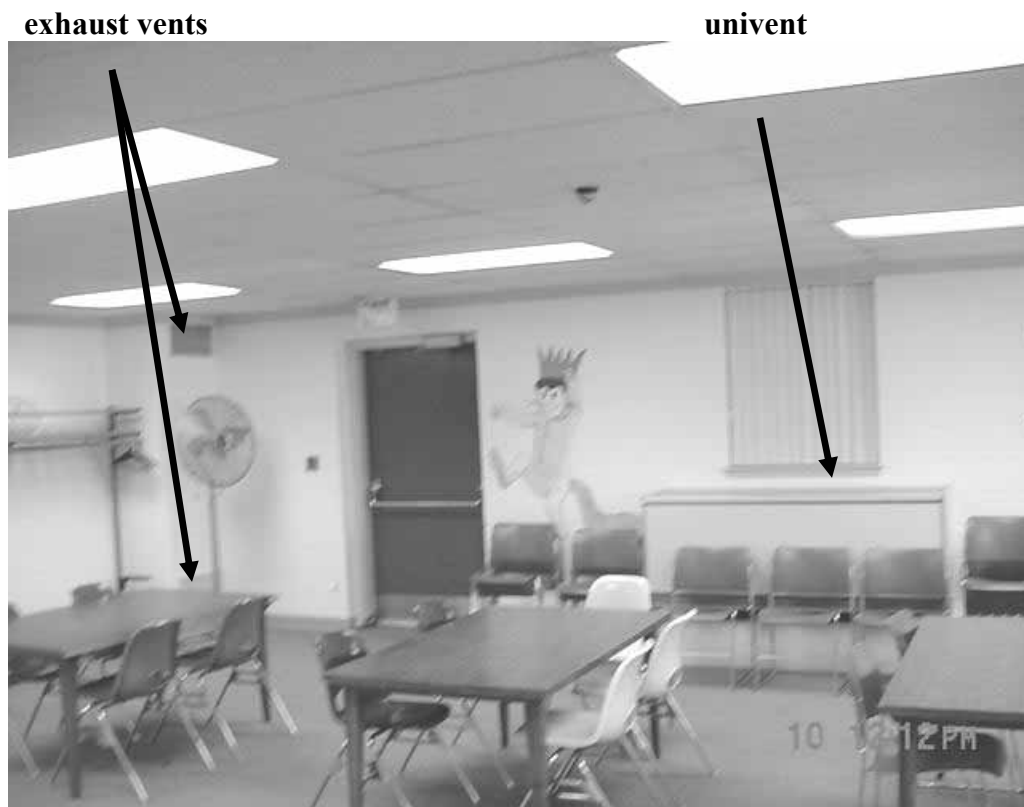
**Picture 2**

The mechanical exhaust ventilation system consists of ceiling- and/or wall-mounted vents (Pictures 2, 6 and 7) ducted to motors, which are located either above the ceiling tile system or in the attic. At the time of the assessment, a number of exhaust vents were not operating (Table 1), which indicates that motors had either been deactivated or were not operable. In addition, the passive vent in the door to the main office behind the circulation desk had been removed (Picture 8). With the door closed, no make up air is available to the main office. Without dilution by the introduction of fresh air via the univents and removal by the exhaust ventilation system, normally occurring environmental pollutants can build up and lead to indoor air/comfort complaints.

**Unit Ventilator and Wall-Mounted Exhaust Vents in Basement Auditorium**

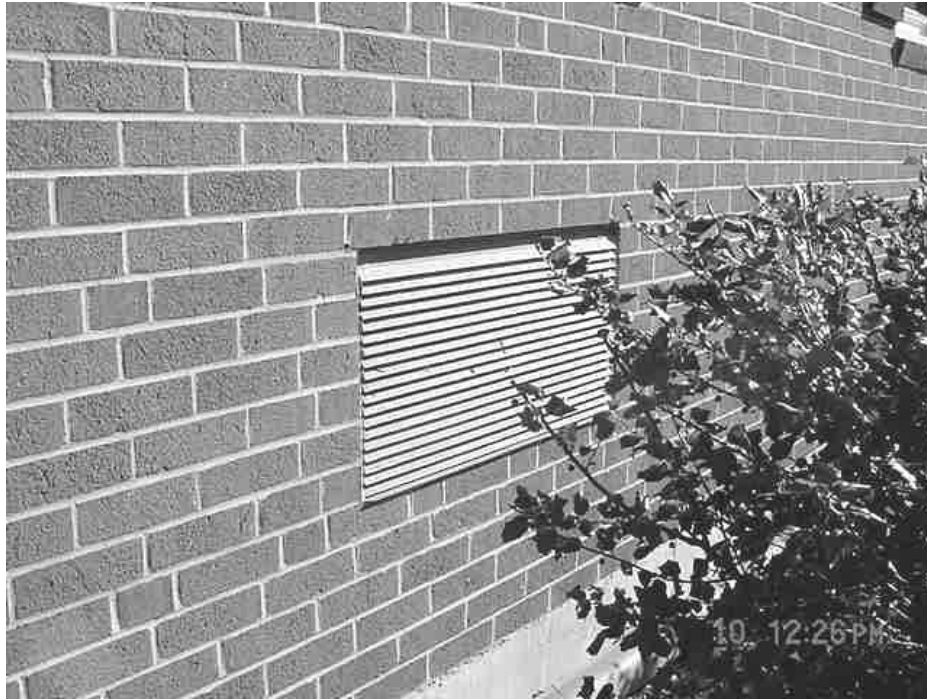
**Picture 3**

located on the exterior wall of the building (Picture 3). Fresh air intakes for basement level univents are located in concrete-lined subterranean pits (Picture 4). Return air for the univent is drawn through an air intake located at the base of the unit ([Figure 1](#)). Fresh and return air are mixed, filtered, cooled/heated and provided to occupied areas through an air diffuser located in the top of the unit. Univents have manual fan controls of low, medium and high to adjust fan speed (Picture 5). Univents were found deactivated and inoperable in a number of areas. In order for univents to provide fresh air as designed, they must be activated and allowed to operate while rooms are occupied. As previously discussed, univents are reportedly original, approximately 30-35 years old. Univents of this age can be difficult to maintain because replacement parts are often unavailable.

**Univent Fresh Air Intake**

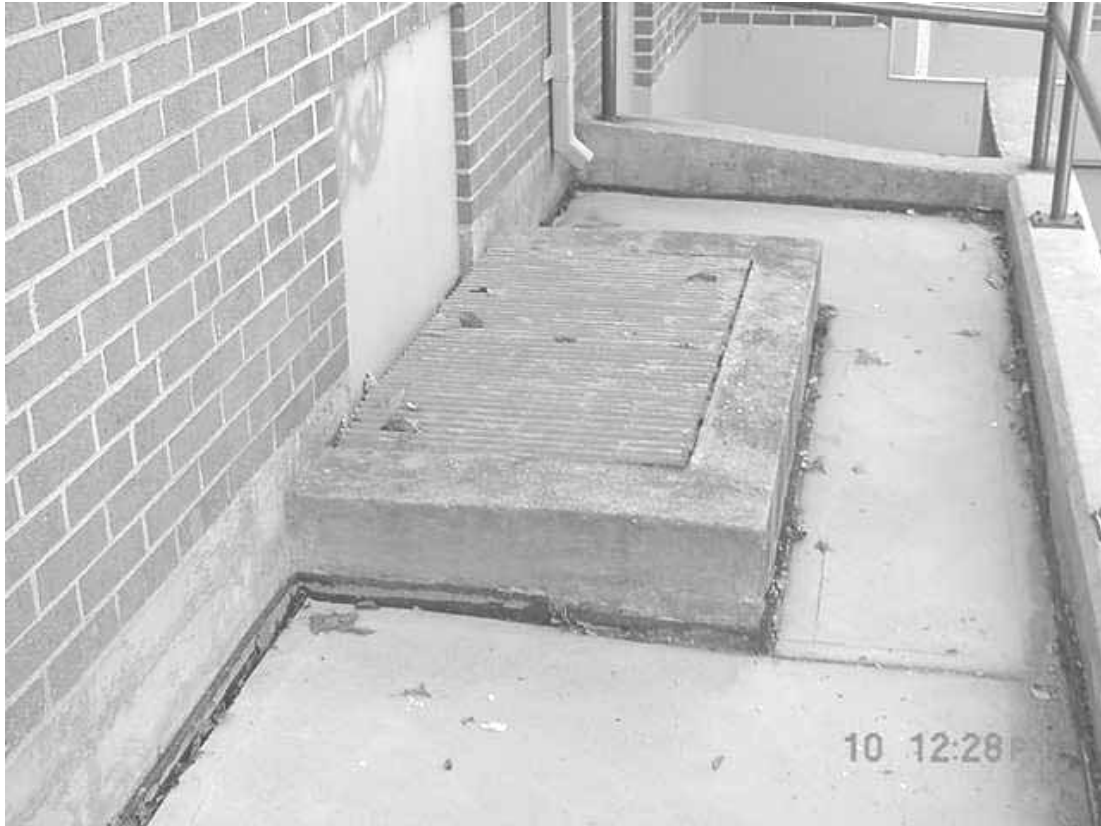
**Picture 4**

As discussed several subterranean pits were located along the perimeter of the building (Picture 4). These pits allow airflow into below grade air intakes for the mechanical ventilation system. Leaves, papers and other debris were observed on the bottom of the pits (Picture 14), which can provide a source of mold growth. Mold odors and growth can subsequently be entrained into the ventilation system and distributed to occupied areas.

**Subterranean Concrete-Lined Pit for Univent Fresh Air Intake**

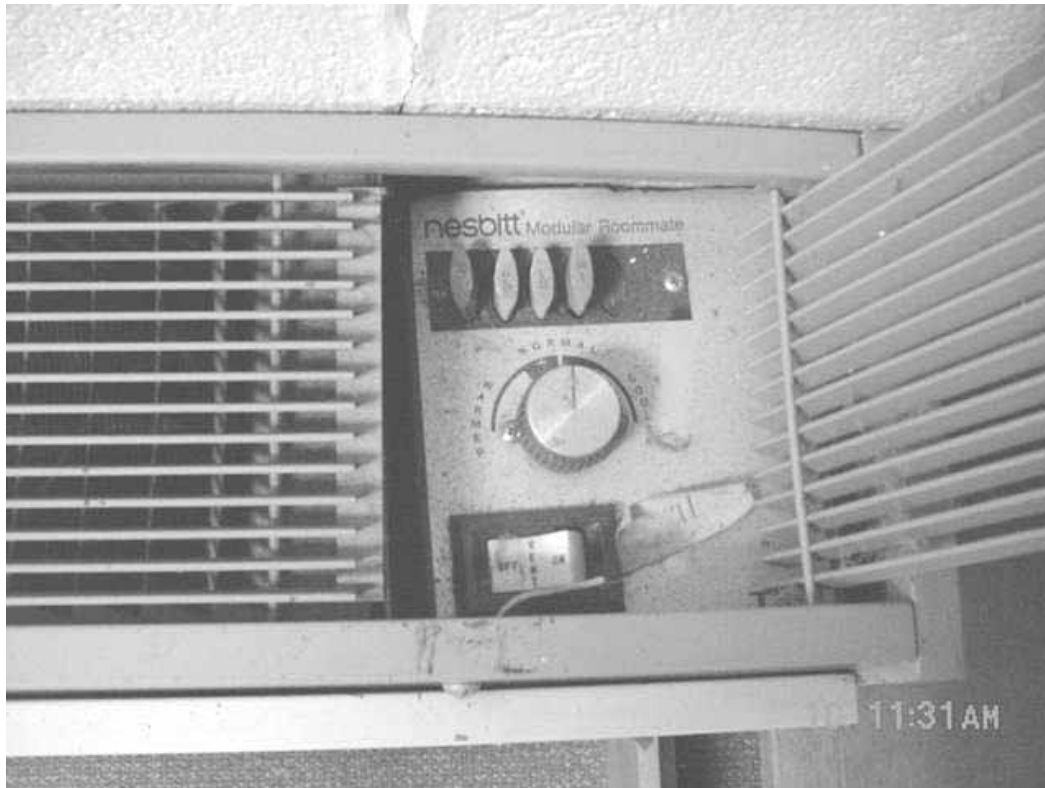
**Picture 5**

**Univent Control Panel, Fan Speed Control Buttons along top,  
Also Note Vent On/Off Control at Bottom**

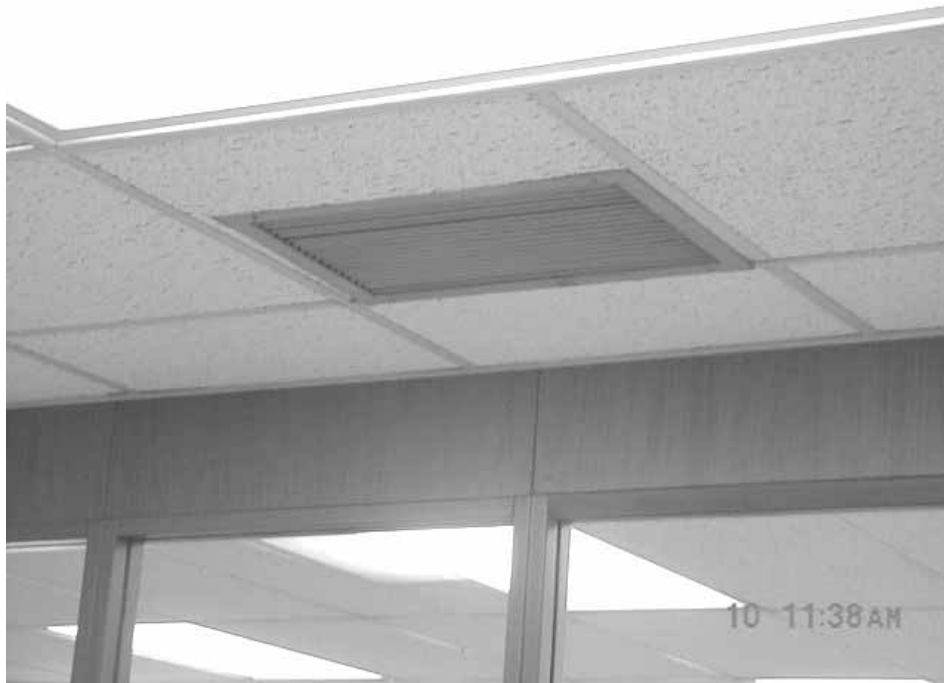
**Picture 6**

**Ceiling-Mounted Exhaust Vent in Main Office**

3. Restore the general exhaust ventilation system. Inspect exhaust motors and belts for proper function, repair and replace as necessary.
4. Supplement airflow by opening windows and operating air conditioners in the “Fan Only” setting to introduce outside air.

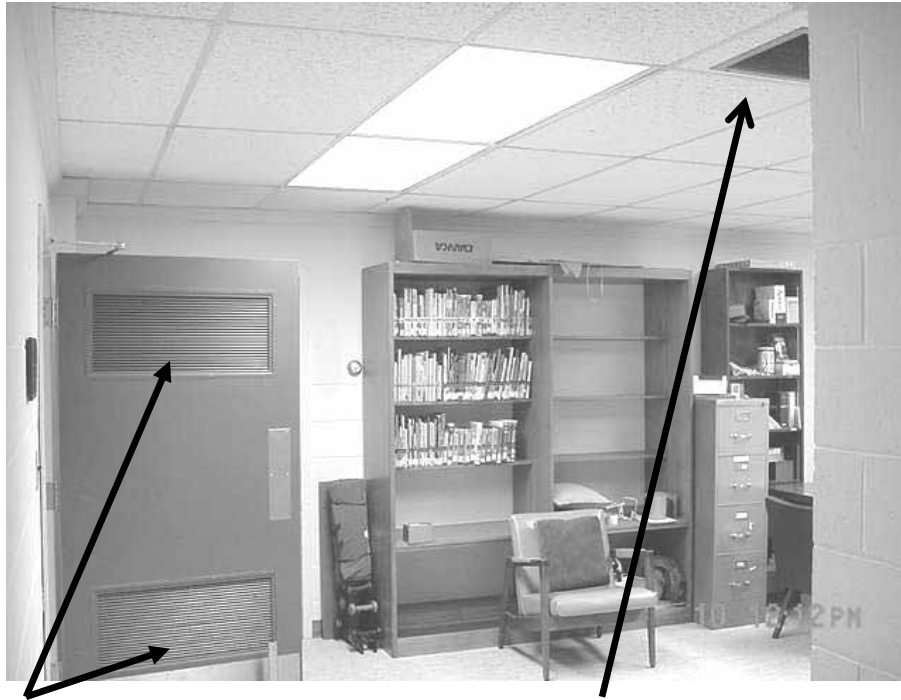
**Picture 7**

**Passive Door Vents and Ceiling-Mounted Exhaust Vent in Basement Kitchen**

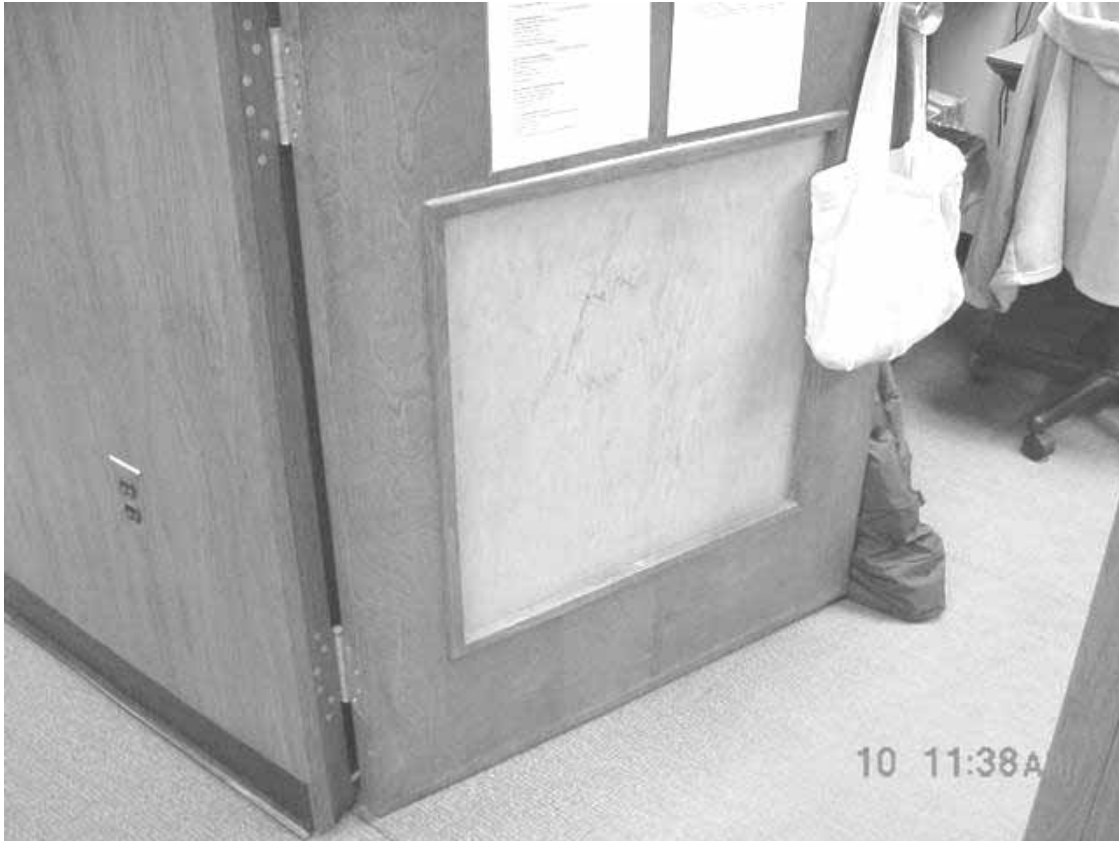
**Picture 8**

**Solid Door Panel in Main Office Door**

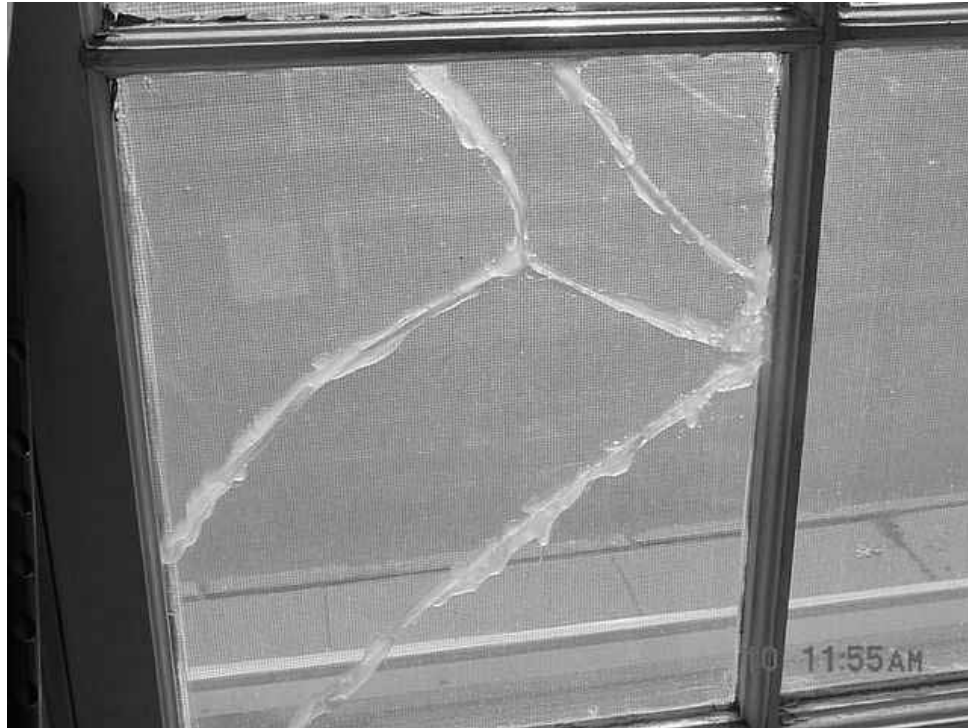
**Picture 9**

Facilitating the mechanical ventilation system in the building are openable windows. Occupants reported that windows in several areas are broken, in disrepair or have been temporarily sealed for security reasons (Pictures 9 and 10). In a number of cases, openable windows have been eliminated with the permanent installation of window-

**Broken/Repaired Glass Window Pane on Main Floor**

5. Work with staff to determine which windows are unopenable/difficult to operate and make repairs. Consider removing plexiglass from auditorium windows.

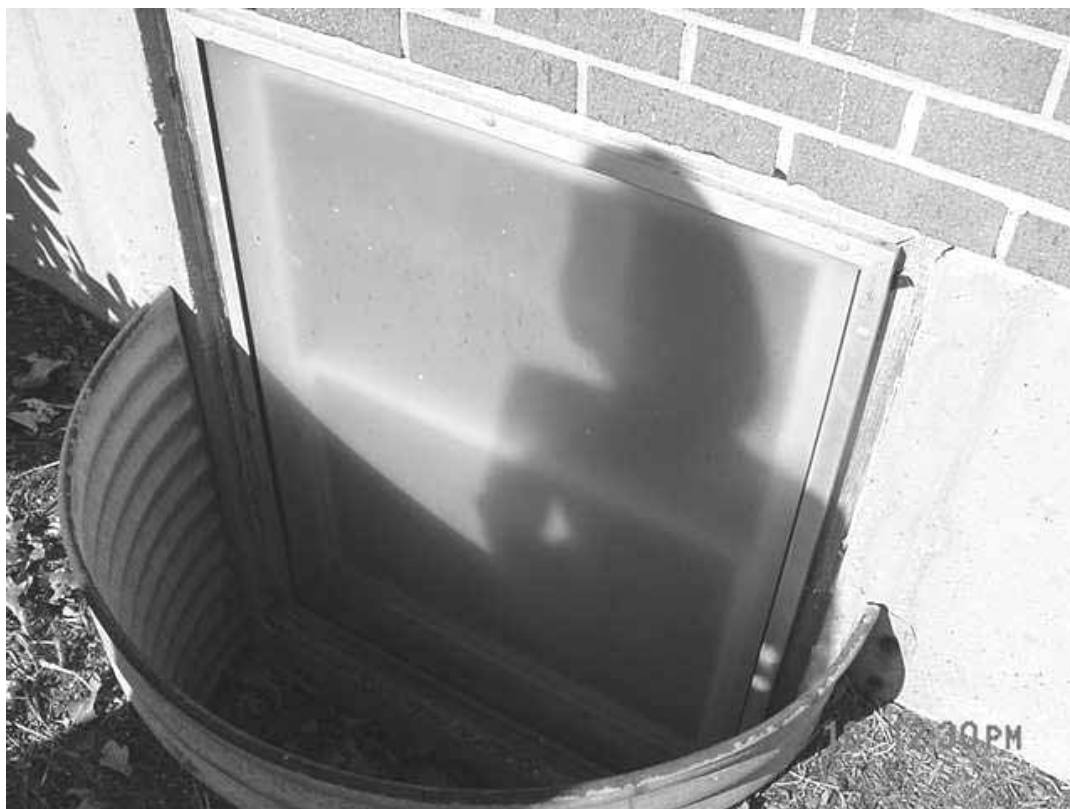
**Picture 10**

**Auditorium Window Sealed with Plexiglass**

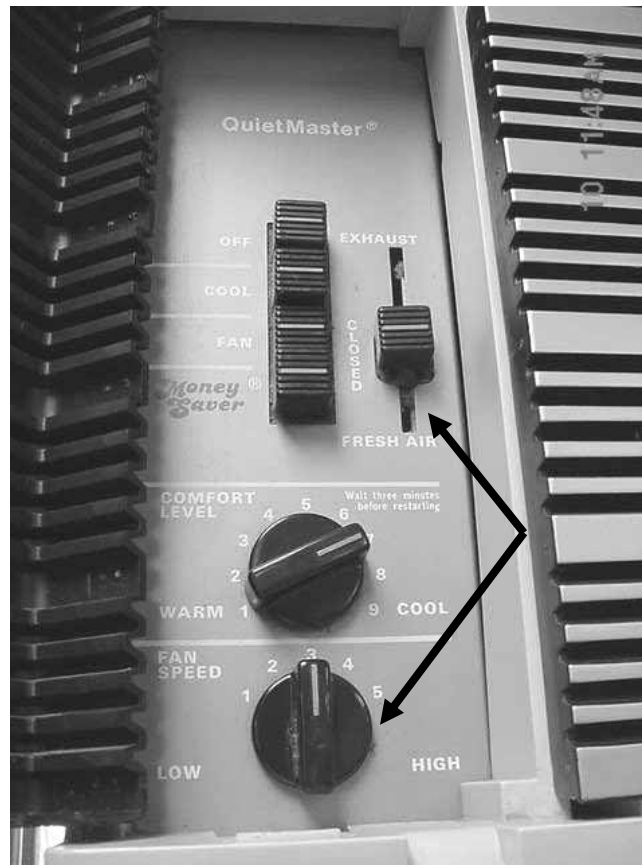
Picture 11

mounted air conditioners. The air conditioners are equipped with a “fan only” or “exhaust open” setting (Picture 11). Operating air conditioning units in either of these modes can provide air circulation, since outside air is delivered without cooling (i.e., air provided by unit equals that of outside temperature).

**Air Conditioner Control Panel Note Fan and Fresh Air Controls**

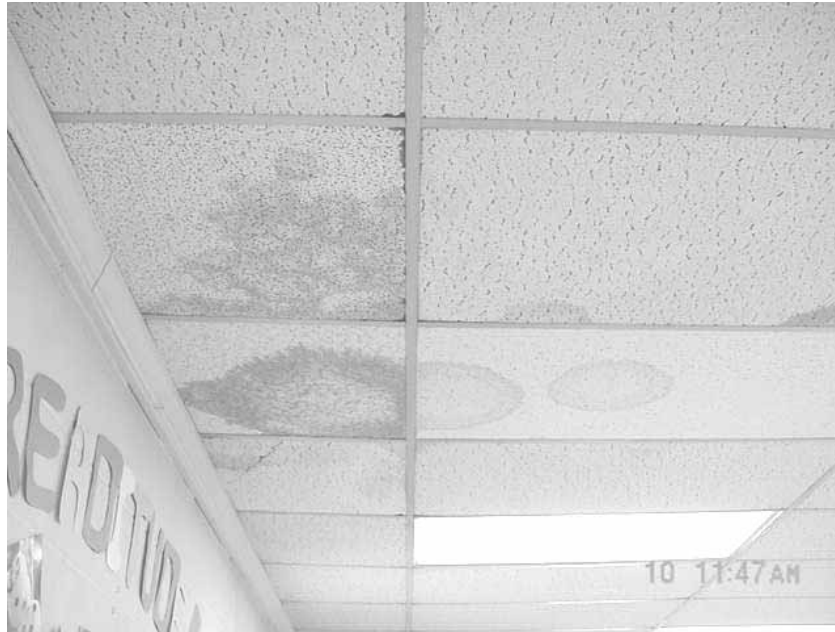
**Picture 12**

A few areas had water damaged ceiling tiles, which can indicate leaks from the roof or plumbing system (Picture 12). Water damaged ceiling tiles can provide a source of mold and should be replaced after a water leak is discovered and repaired. Concerns of

mold growth in this area were expressed by occupants. BEHA staff removed a number of tiles to examine conditions above the ceiling plenum. The plenum above the ceiling tiles was insulated with fiberglass, some of which appeared water damaged. Moisture measurements of ceiling tiles and insulation in this area were low during the assessment.

**Water Damaged Ceiling Tiles in Main Portion of the Library, Note Water Damaged Fiberglass Insulation Above Tiles in This Area**

10. Ensure roof/plumbing leaks are repaired, and replace any remaining water-damaged ceiling tiles and fiberglass insulation. Examine the area above and around these areas for mold growth. Disinfect areas of water leaks with an appropriate antimicrobial as necessary. Conduct work above ceiling tiles during *unoccupied* periods or periods of low occupancy. Once work is completed wet wipe and/or vacuum area with a HEPA filtered vacuum cleaner to clean up all residual dirt, dust and particulates.

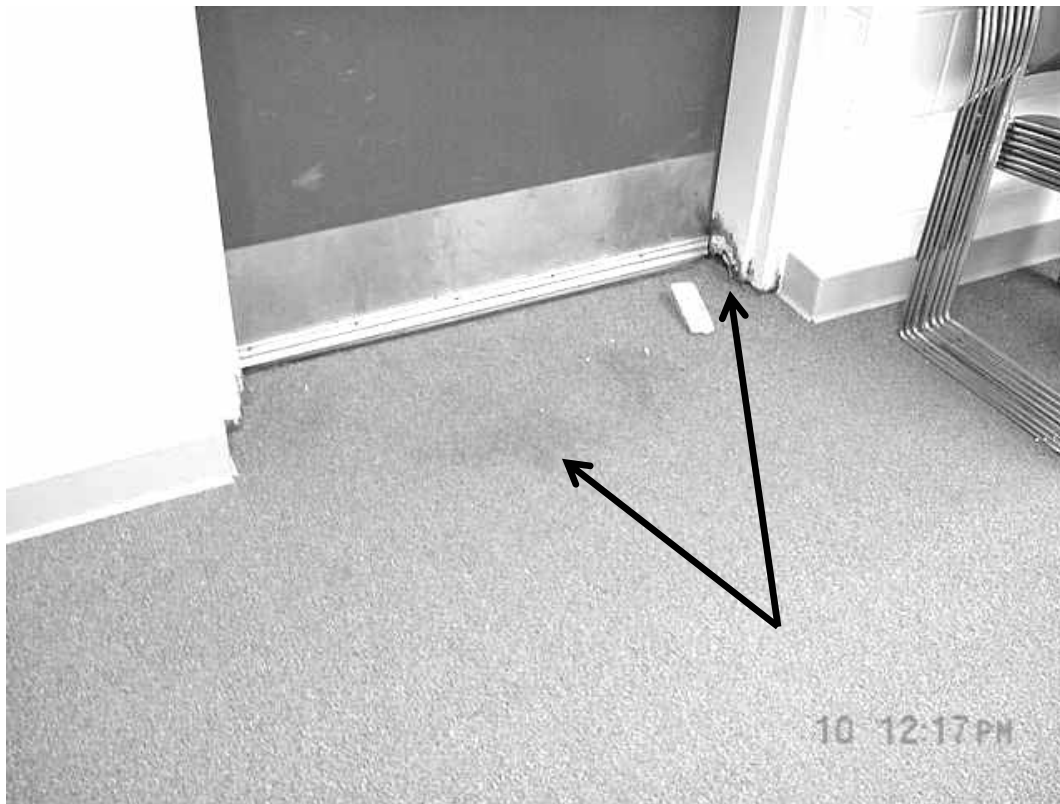
**Picture 13**

Water damaged carpeting was observed near the basement entrance/handicapped access ramp (Picture 13). This area is equipped with exterior drainage, however occupants reported that water penetration occurs periodically during heavy driving rains. Moisture measurements of carpeting in this area were low during the assessment. The US Environmental Protection Agency (US EPA) and the American Conference of Governmental Industrial Hygienists (ACGIH) recommends that porous materials be dried with fans and heating within 24 to 48 hours of becoming wet (US EPA, 2001; ACGIH, 1989). If porous materials are not dried within this time frame, mold growth may occur. Water damaged porous materials cannot be adequately cleaned to remove mold growth. The application of a mildewcide to moldy porous materials is not recommended.

**Water Damaged Carpeting and Door Jamn in Basement Auditorium**

11. Consider removing water-damaged section of carpeting around auditorium exterior door and replacing with tile or other non-porous floor material.
12. Remove leaves and debris from subterranean pits seasonally.

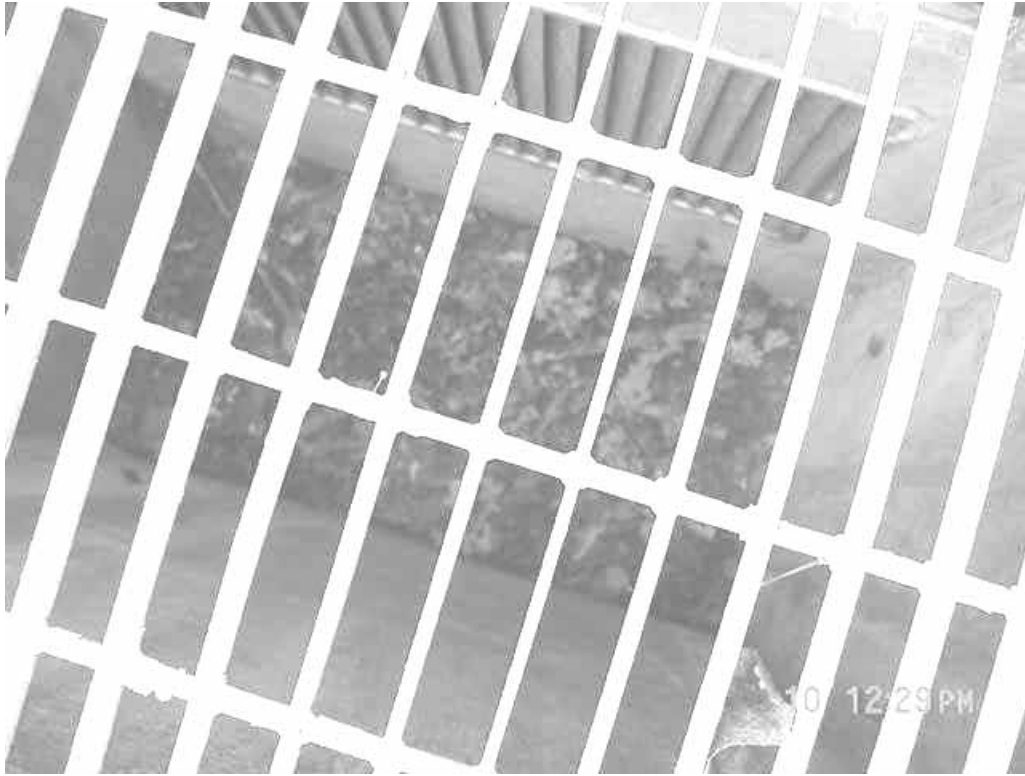
**Picture 14**

**Leaves and Debris at the Bottom of Univent Air Intake Pit**

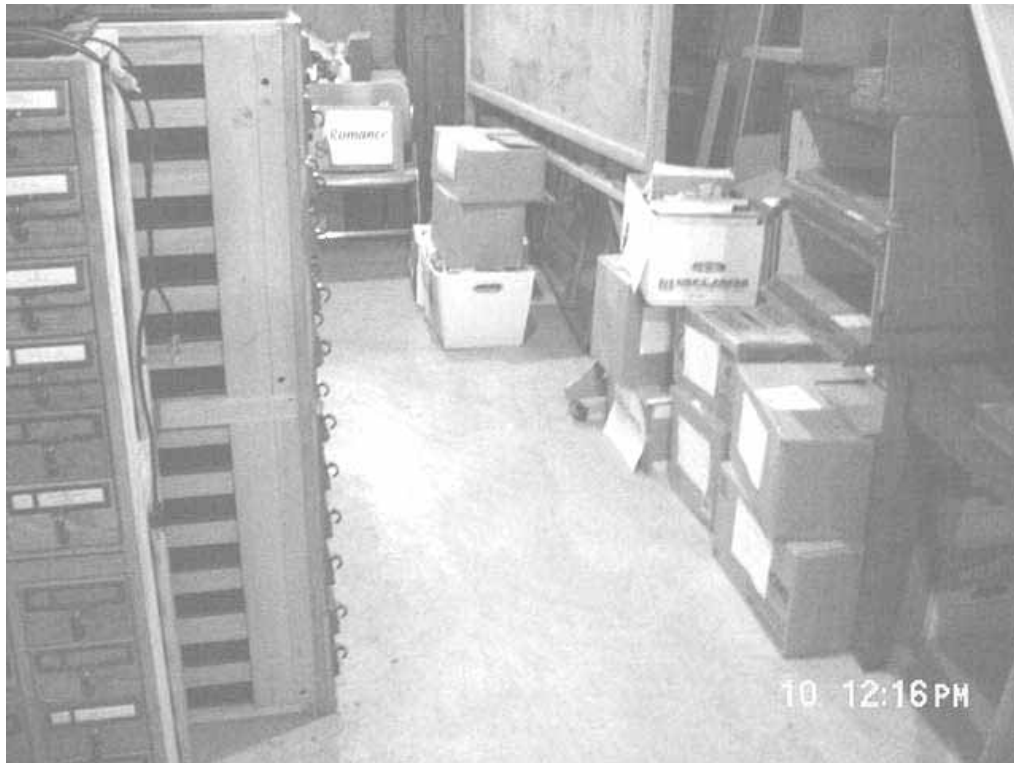
**Picture 15**

The basement contains a storeroom with a cement floor. BEHA staff observed a large number of cardboard boxes and other porous items stored on the floor (Picture 15).

**Boxes and Other Items Stored on Cement Floor of Basement Storeroom**

These items should be elevated (e.g., placed on pallets, tables) to prevent water damage and potential mold growth.

13. Ensure plants have drip pans. Examine drip pans periodically for mold growth and disinfect with an appropriate antimicrobial where necessary.
14. Do not store porous materials directly on cement floor in basement storage room. Inspect and discard any water damaged cardboard boxes. Disinfect any areas of microbial growth with a one in ten bleach in water solution; wipe clean surfaces with soap and water after disinfection.

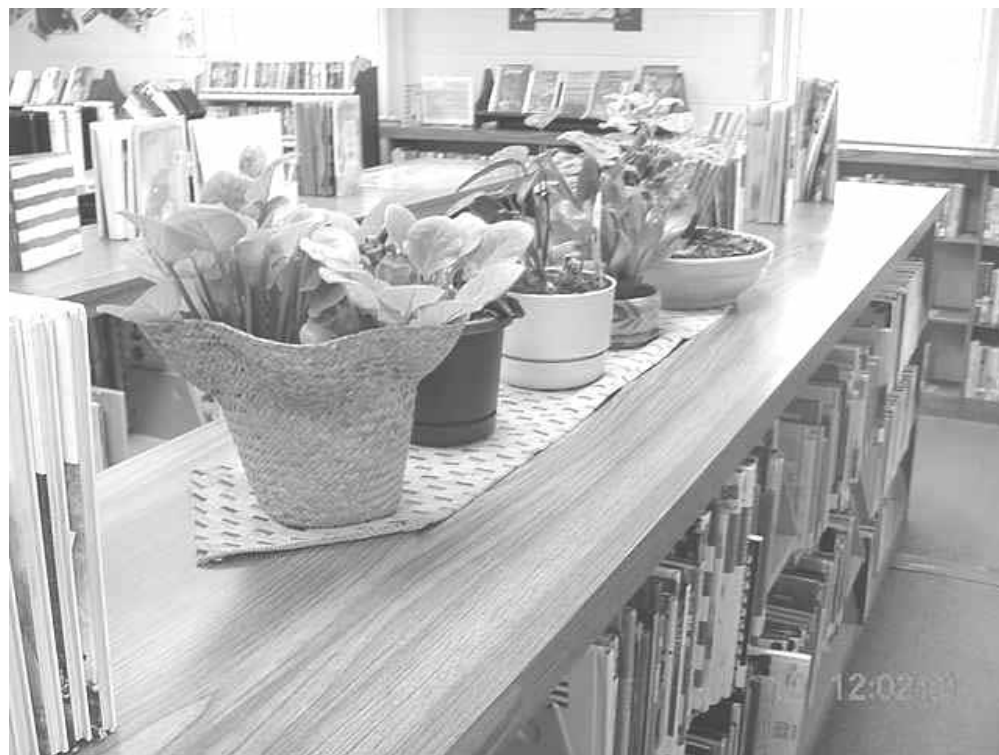
**Picture 16**

Plants were noted in several areas (Picture 16). Plants can be a source of pollen and mold, both of which can be respiratory irritants for some individuals. Plants should be properly maintained and equipped with drip pans. Plants should also be located away from univents to prevent the aerosolization of dirt, pollen or mold.

**Plants on Bookshelf**

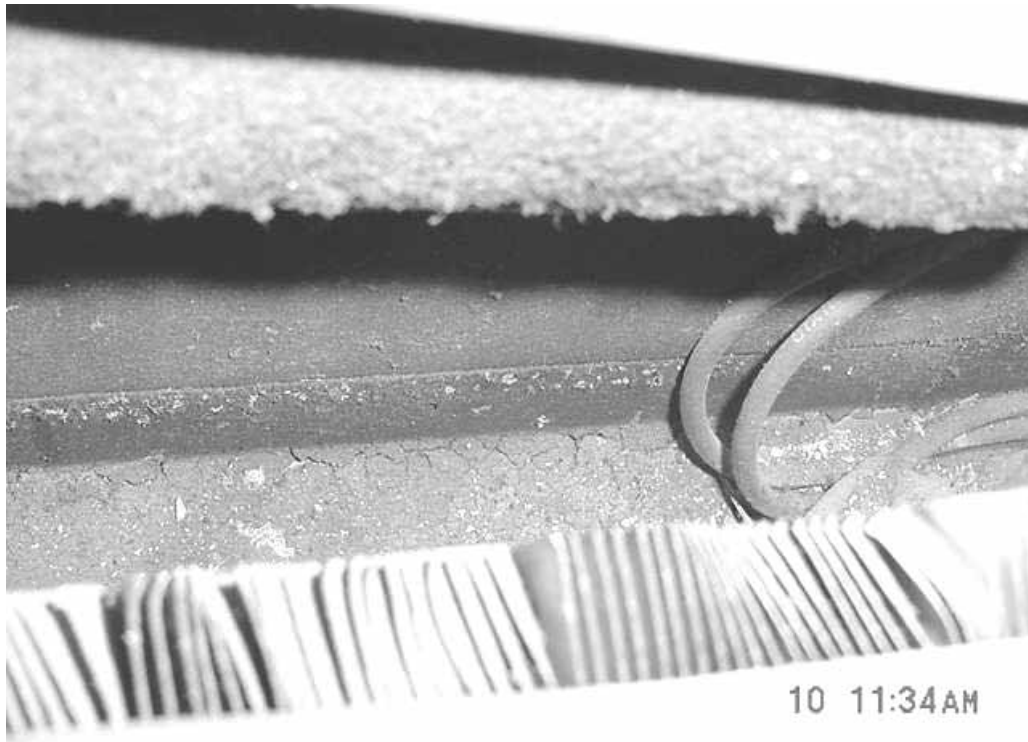
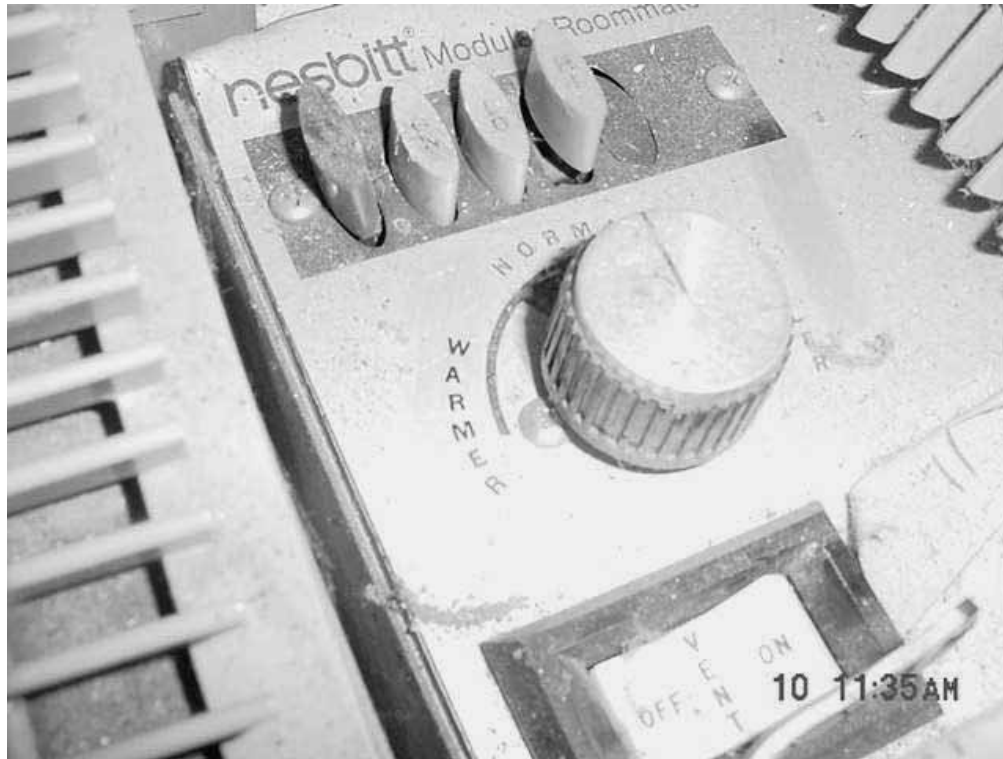
In addition, several univents were opened, and BEHA staff inspected the interior. Accumulated dust and debris was observed (Pictures 17 and 18). The operation of univent fan motors can aerosolize dust particles. In addition, these materials can accumulate on flat surfaces (e.g., desktops, shelving and carpets) in occupied areas and subsequently be re-aerosolized causing further irritation.

**Acuumulated Dirt, Dust and Debris inside Univent Air Handling Chamber**

**Accumulated Dirt, Dust and Debris inside Univent Control Panel**
